City of Weyauwega
Space Needs Analysis

January 3, 2012

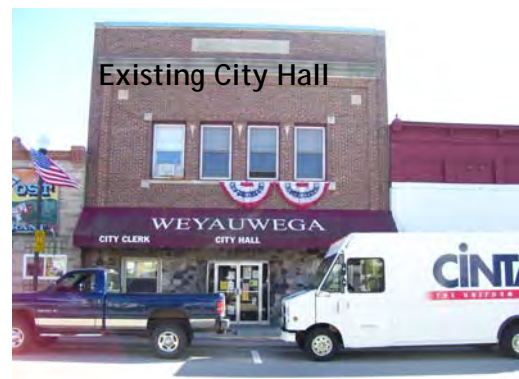
The existing historic "City Hall" building is approximately 33'-8" x 56'-0" and has 1,883 square feet on each floor with two floors totaling 3,766 square feet. The building also has a 1,650 square foot basement level that is used for storage and mechanical equipment. It is estimated that the building is approximately 90 years old and has served as the City Hall with Police Department on the second floor since the building was constructed. It also originally housed the Fire Department on the first floor, which explains the unusually high ceiling height, resulting in a floor to floor height of 13'-6" in this space.

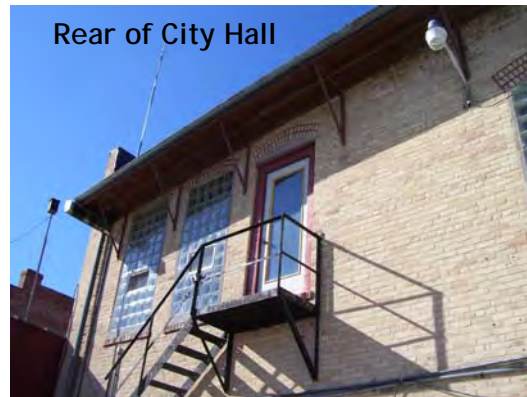
Building Envelope - The City Hall building is a double-wythe brick building with wood framing inside the exterior walls. The brick on the front and rear walls appear to be in fair to good condition and do not contain any apparent cracking from differential settlement. Any interior bearing elements, if they exist, are not known at this time and will have to be further examined if this structure is to be renovated. The existing floor and roof structures are wood framed and appear to be in fair to good condition.

The floor framing systems for the main floor utilizes wood beams extending from north to south in the building with wood framing infilling from east to west. The second floor framing system utilizes steel beams spanning east to west with wood framing infilling from north to south. These framing systems would require further structural inspection, analysis and calculations to determine their suitability and if necessary the extent reinforcement. The existing windows are not original or energy efficient. The roof has a rubber EPDM single ply membrane, which drains toward the rear of the building. Age of the roofing materials is unknown. If the facility is renovated it will likely require additional structural reinforcement and additional insulation.

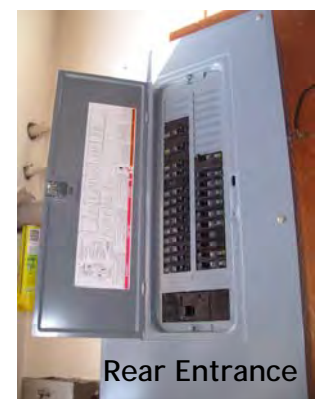
Electrical - The electrical distribution does not meet the current electrical code and it could also be assumed that based on the equipment, fixtures, and building systems, the facility does not meet the current energy code. If the building were to be renovated the electrical distribution and lighting systems would need to be replaced. This will include upgrading the electrical service from a 120/240 volt, 1 phase, to a 102/208 volt, 3 phase, 400 ampere service. The lighting system in the building likely does not meet the current energy code, and with outdated lighting technology should be replaced to improve the energy efficiency of the building. In addition to not meeting the current codes, it will be more cost effective to remove the entire existing system rather than patching into the existing system. The layout of the proposed renovation will likely be such that a remodeled system will cost more and be less user friendly.

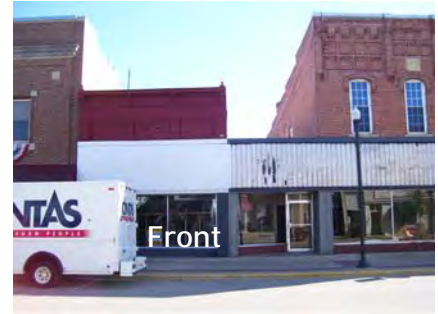
The existing single story Taxidermy Building is approximately 20'-0" x 68'-0", 1,360 square feet with a basement level that is used for storage and mechanical equipment. The building is likely similar in age to the adjacent Mall Building, due to the ornate brick work. It is likely that this building has had several uses over its history. The building has a similar floor to ceiling height as the adjacent buildings. This floor to ceiling height creates a taller front façade, compared to a typical single story building. This roof structure depth would not accommodate a second level and would require extensive demolition and renovation to create a useable second level or access between the buildings.

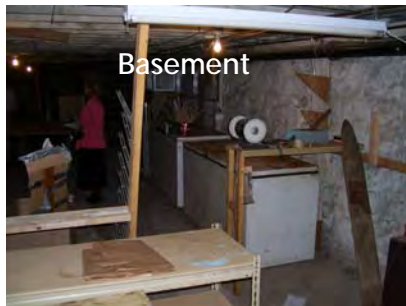
Accessibility - This building is at grade and meets the ADA requirements for accessibility. Several of the interior elements, including the restrooms, do not meet ADA requirements and would have to be renovated. The basement area is served by an existing stairway which likely also would need to be replaced.

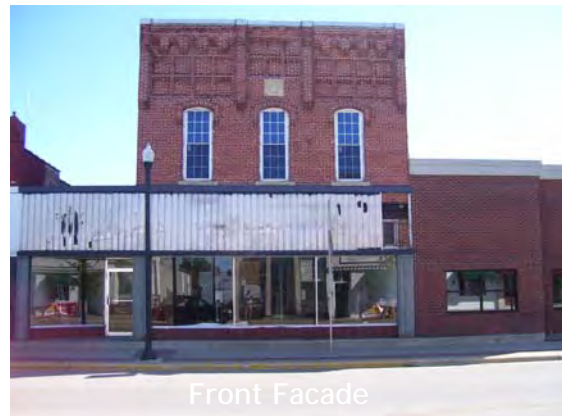
The existing Mall Building is approximately 40'x70', 2,800 square feet, per floor for a total existing building of 5,600 square feet, not including the basement. The 2,800 basement level is used for storage and mechanical equipment. The original portion of the Mall Building was built in 1894 and has likely had several uses over its life. Most recently this building functioned as a restaurant. The floor to floor height in this building is 15'-0", which is approximately 2'6" higher than the existing City Hall.

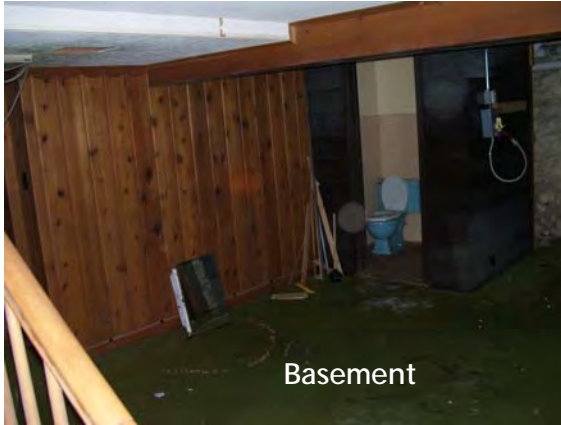
Accessibility - This building is at grade and meets the ADA requirements for accessibility. Several of the interior elements, including the restrooms, do not meet ADA requirements and would have to be renovated. The second floor and basement areas are served by existing stairways which would likely also need to be replaced. This may involve keeping the existing stair and adding a shared accessible stair elsewhere in the project.

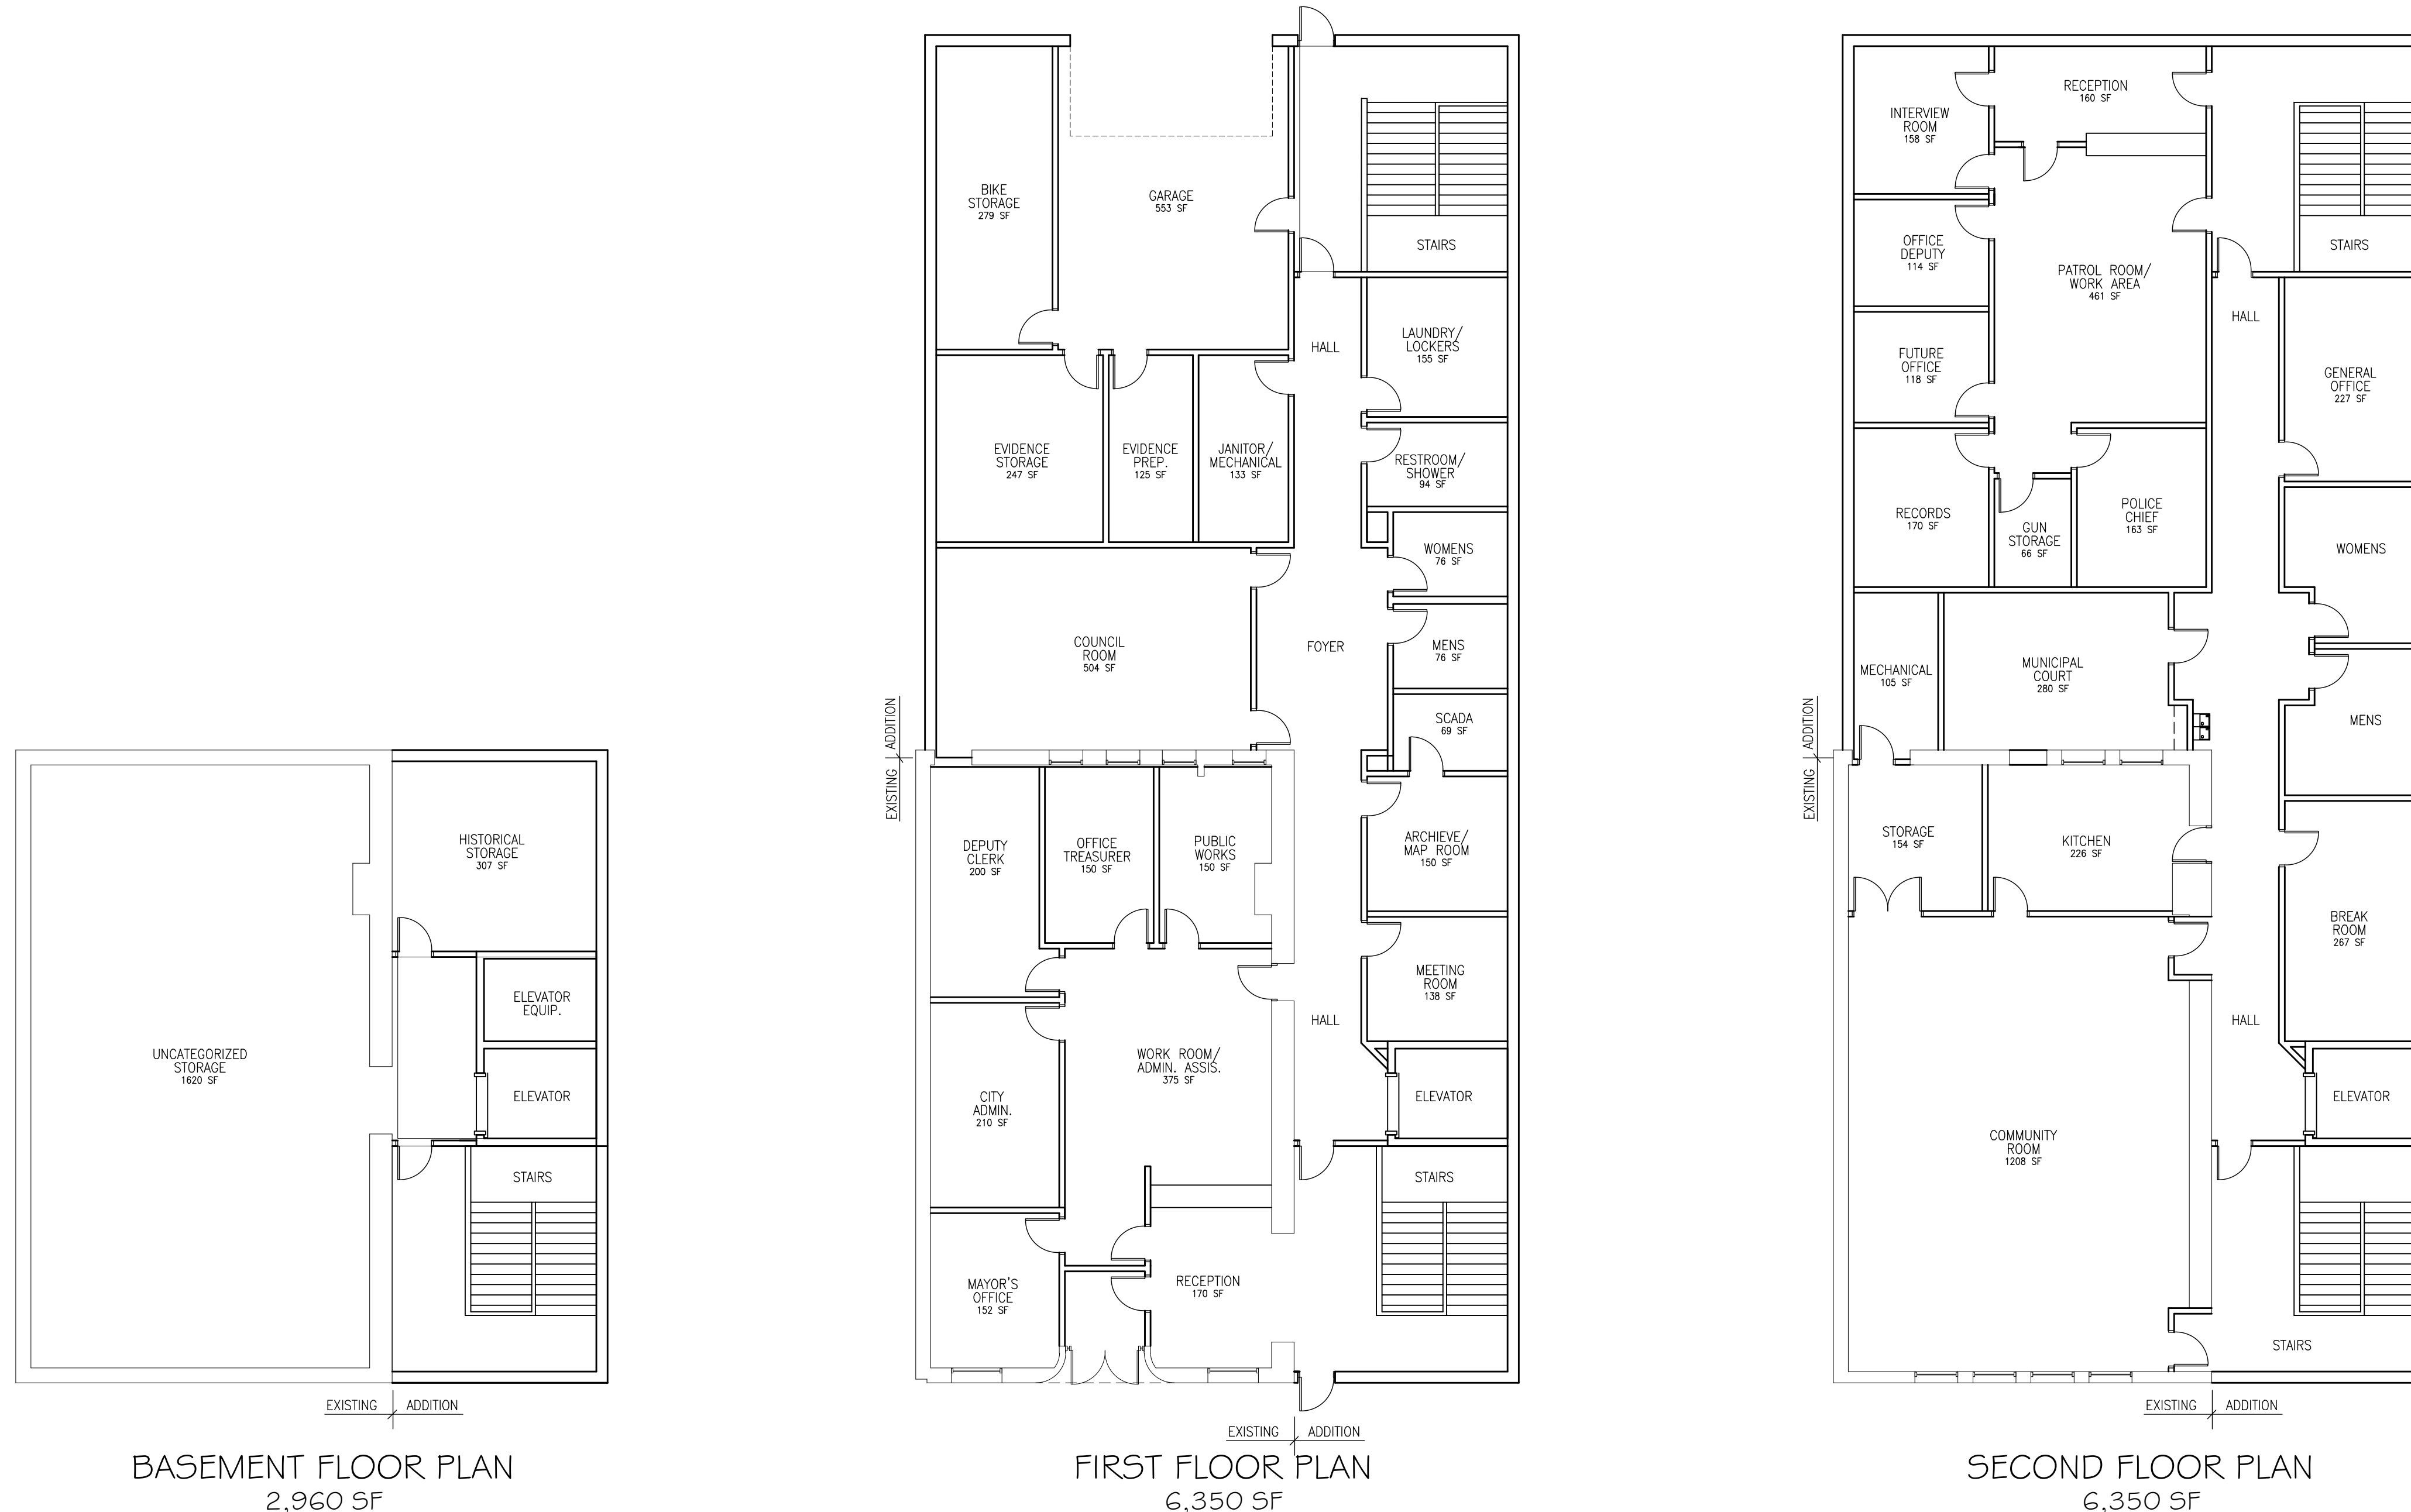
OPTION 1

TWO-STORY ON TWO LOTS

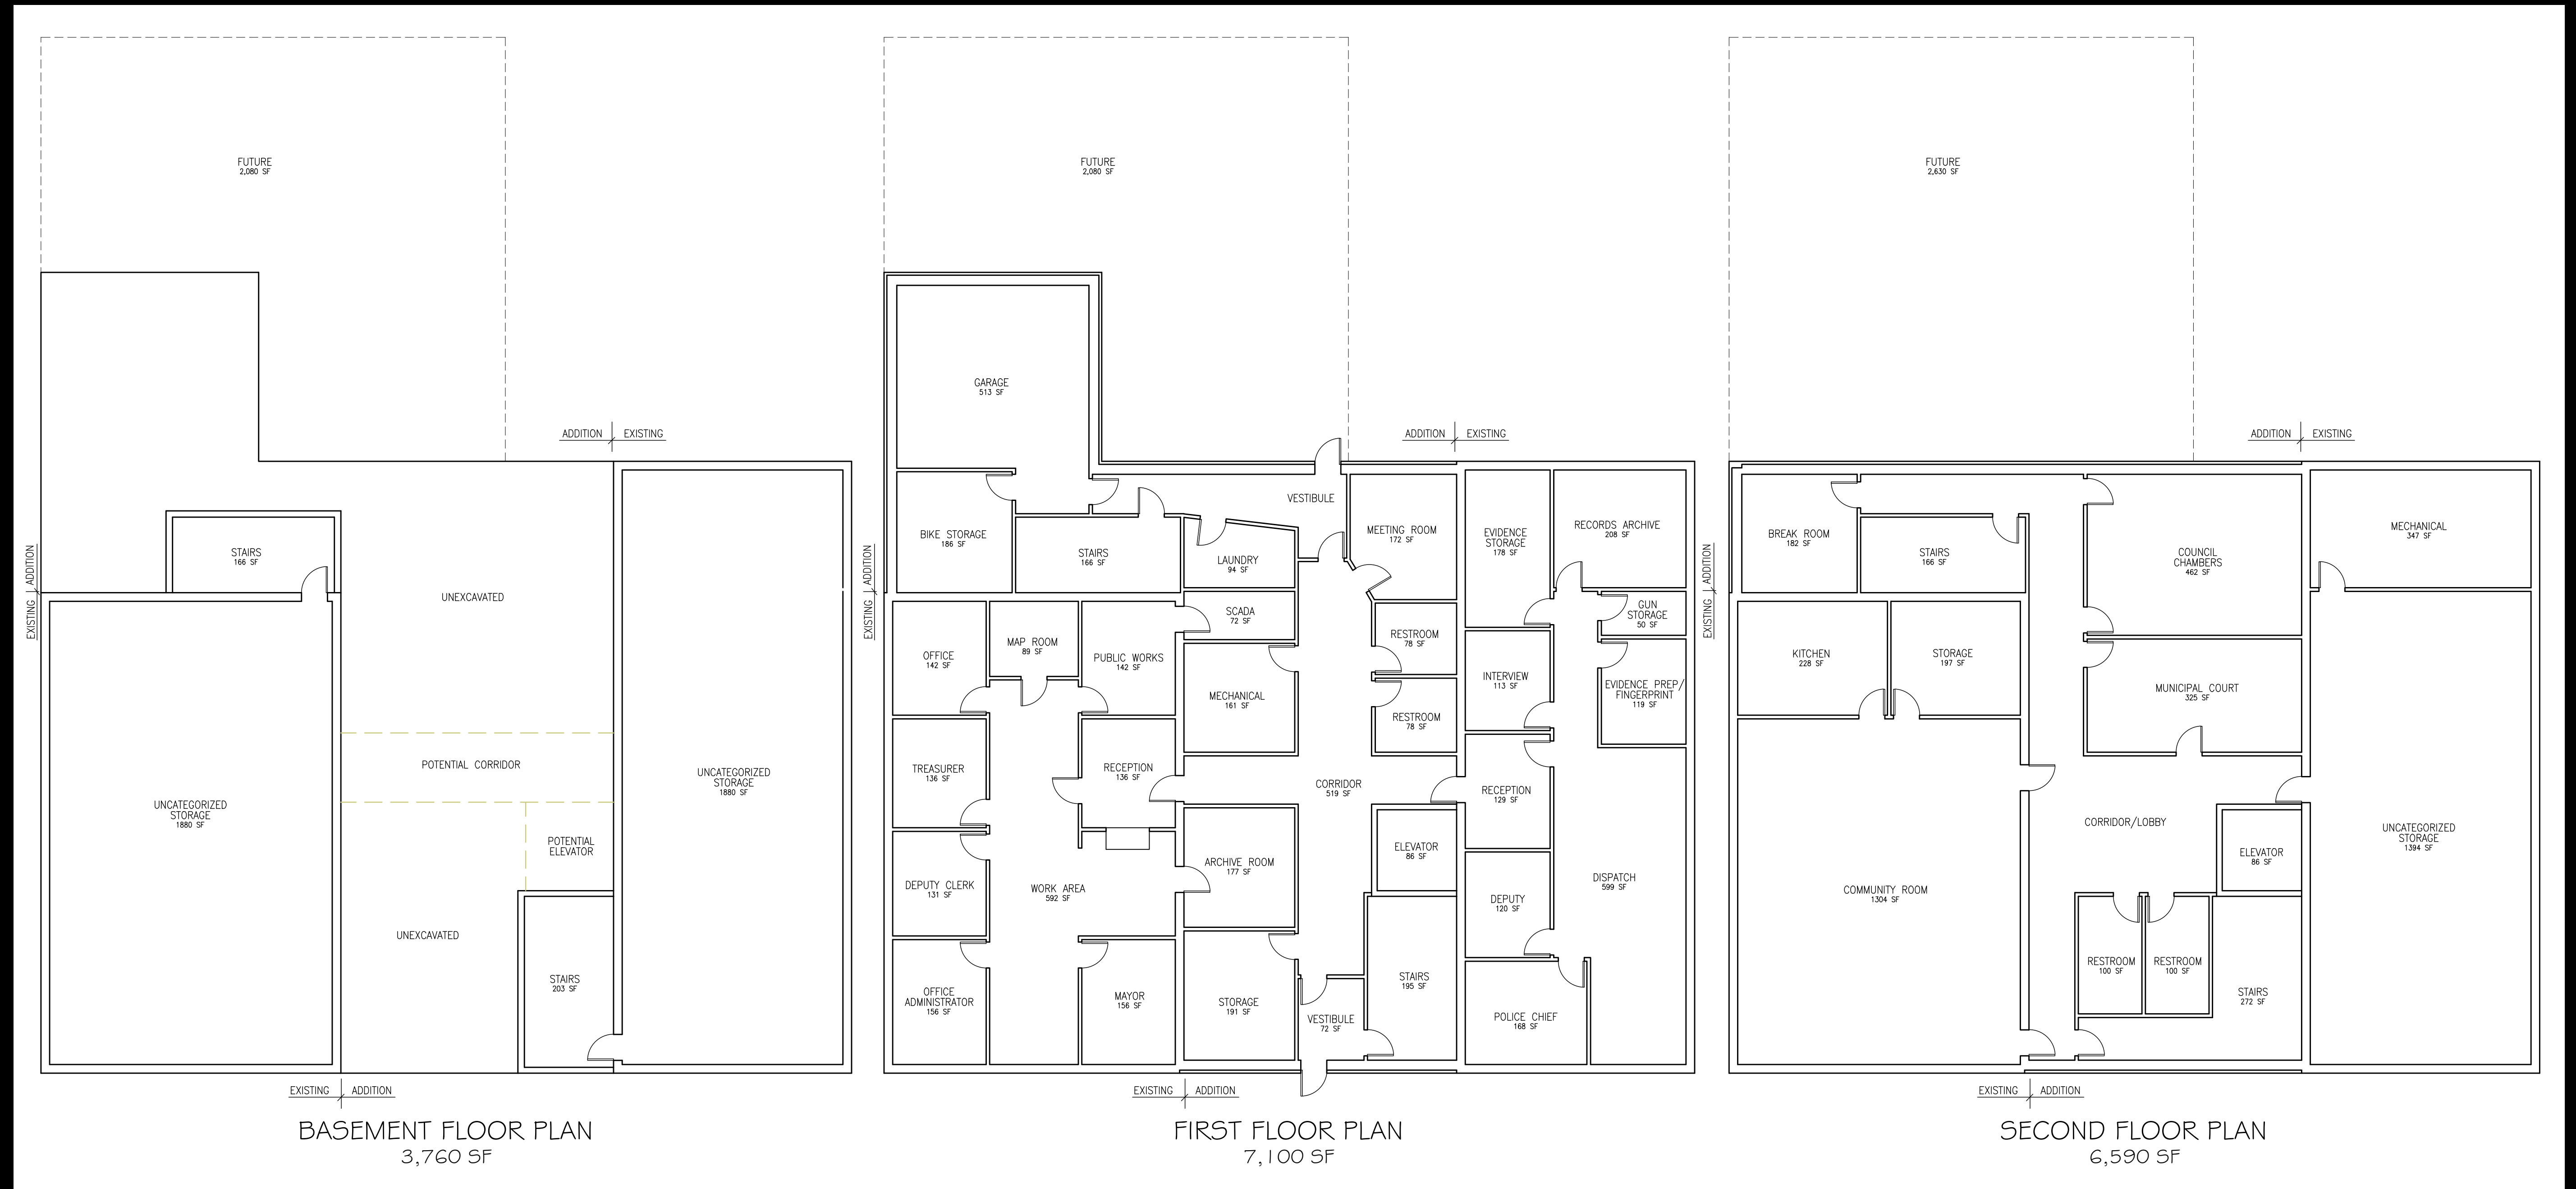
OPTION 2

TWO-STORY ON THREE LOTS

In reviewing the three potential options and the advantages and disadvantages for each option it is our recommendation that the two-story building on three lots, Option #2, is the better alternative for the City's current and future needs. This alternative allows the City to utilize the existing City Hall and Mall buildings during construction, therefore eliminate the need to lease space during construction. By reusing these buildings the City will realize cost savings while both maintaining the existing building's and the downtown character. Building reuse is a large component in 'green' architectural practices, and through the reduction of waste into landfills and minimizing the need for new and raw materials. By re-using existing buildings the City can ensure the beauty of downtown and know that the buildings will not fall into idle hands.

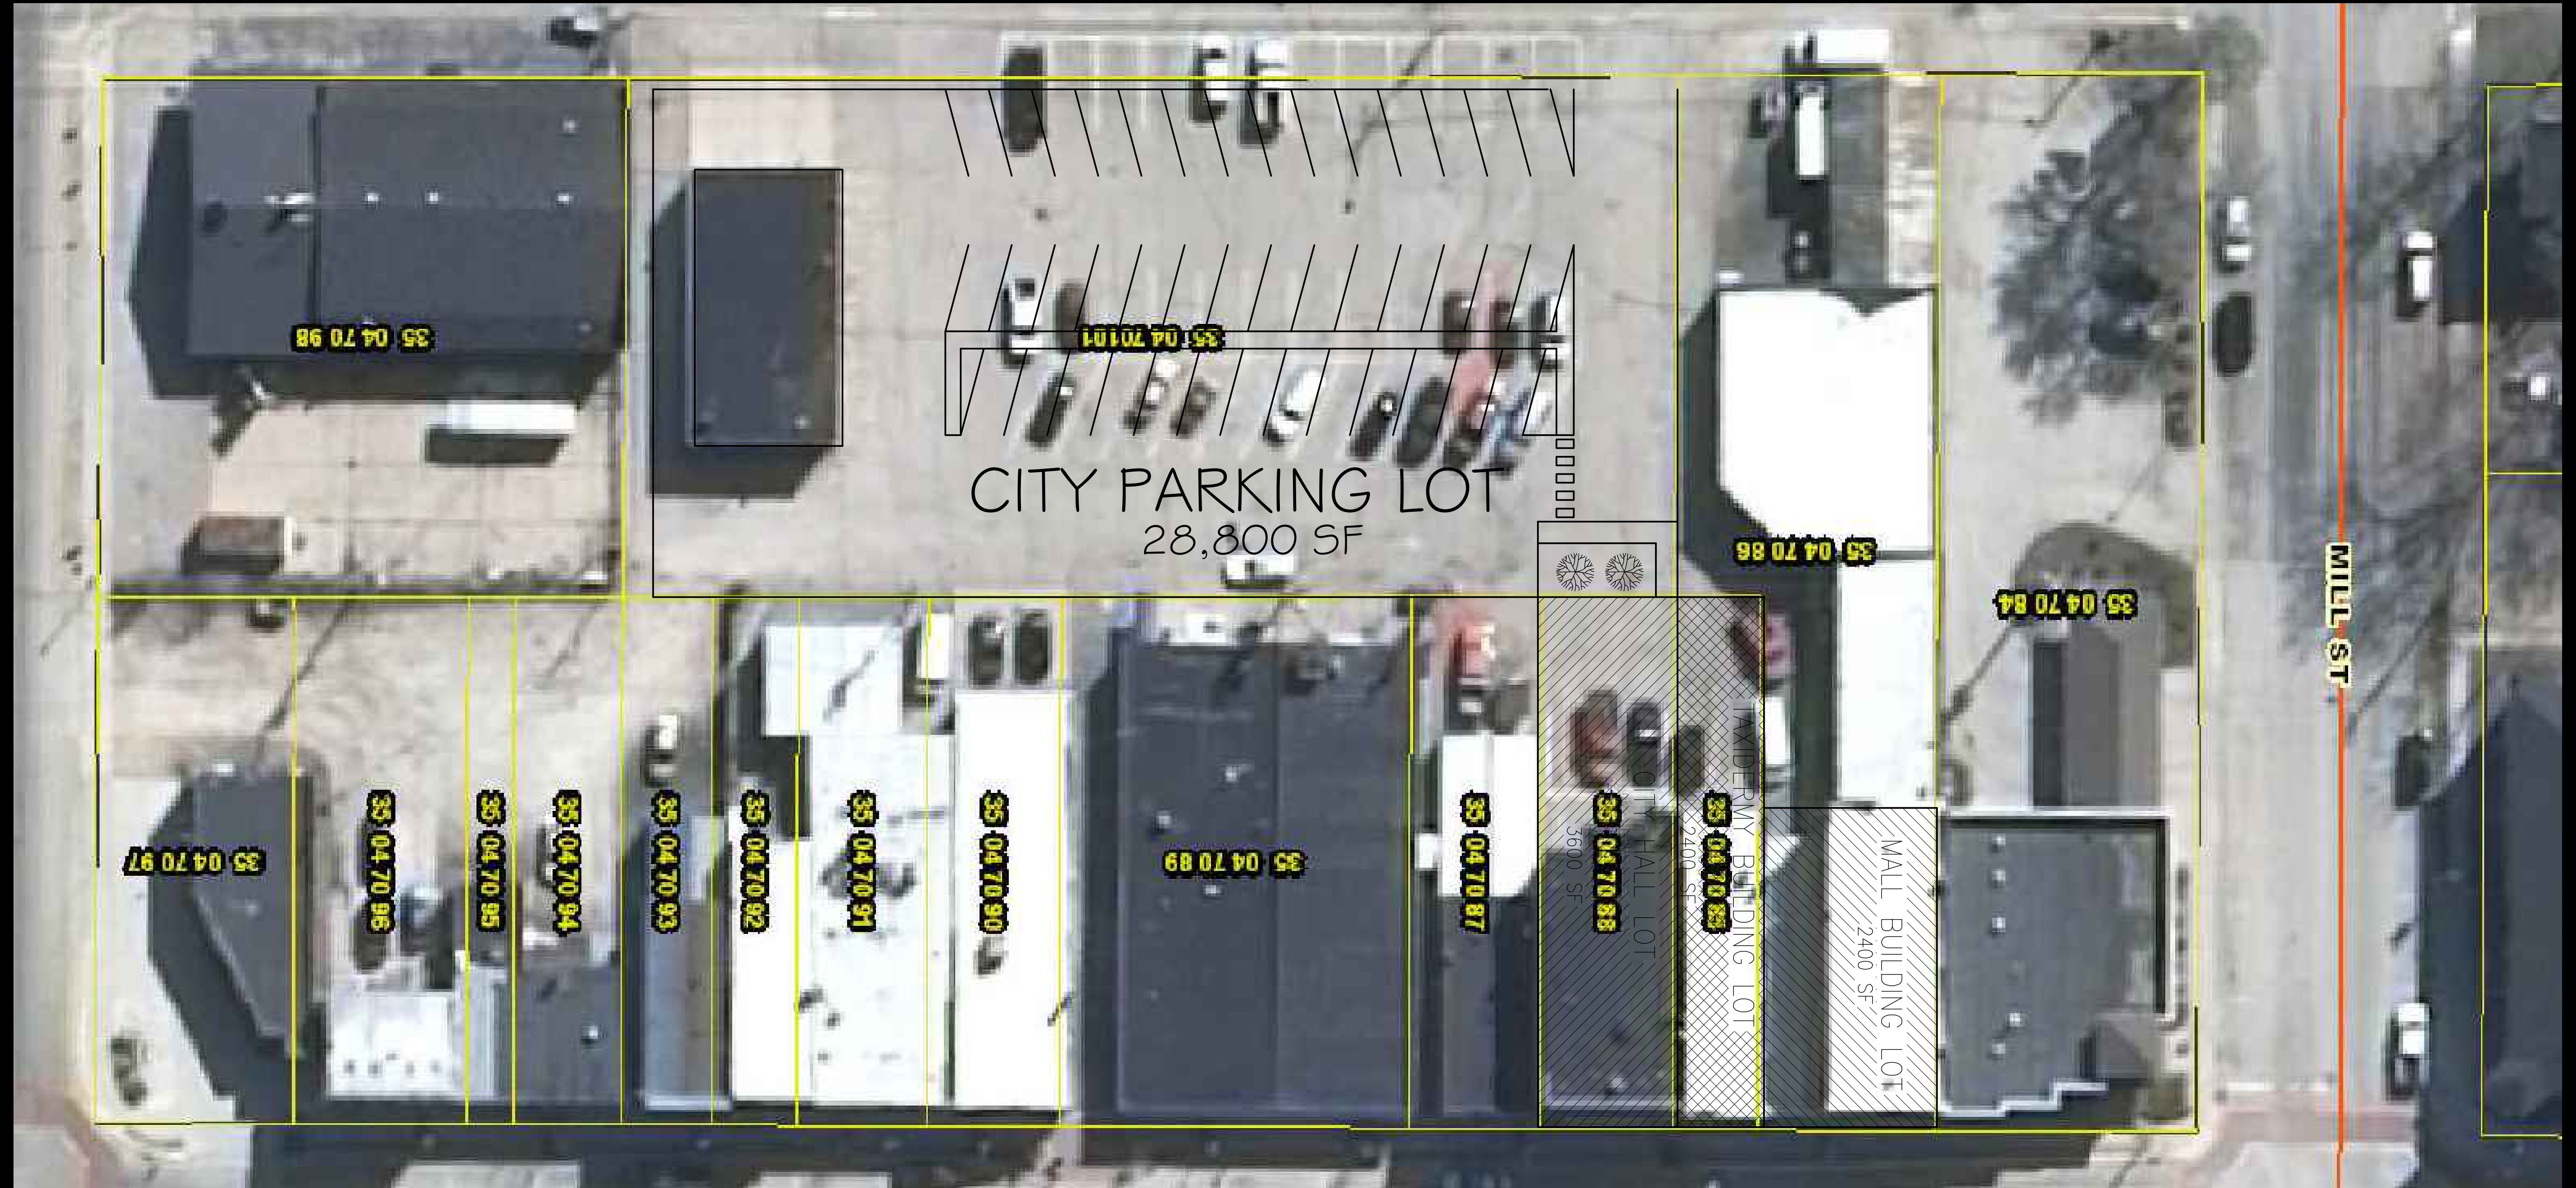
POTENTIAL SITE PLAN
